# An Overview of Microbiologically Influenced Corrosion in Aircraft

By B.J. Little and R.I. Ray

Naval Research Laboratory  
Stennis Space Center, MS 39529

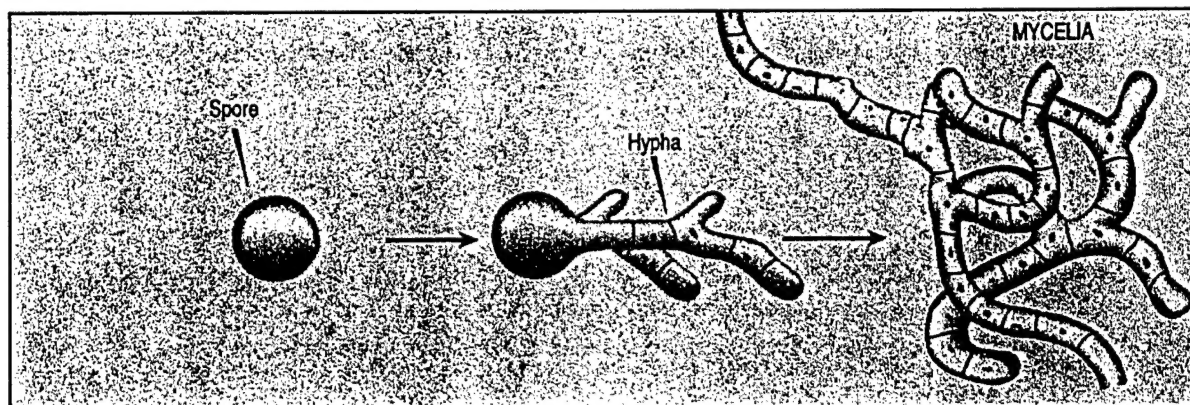
Figure 1. Growth stages of filamentous fungi.

Most documented cases of microbiologically influenced corrosion (MIC) in aircraft are related to fungi. Fungi are desiccant-resistant microorganisms that can remain active down to a relative humidity of 65%. Fungi are nonphotosynthetic organisms, having a vegetative structure known as a hypha, the outgrowth of a single microscopic reproductive cell or spore. A mass of threadlike hyphae make up a mycelium (Figure 1).<sup>1</sup> Mycelia are capable of almost indefinite growth in the presence of adequate moisture and nutrients so that fungi often reach macroscopic dimensions. Yeasts are fungi that multiply by forming buds instead of mycelia. Fungi are ubiquitous in atmospheric and aquatic environments where they assimilate organic material and produce organic acids including oxalic, lactic, acetic, and citric. Spores, the nonvegetative dormant stage, can survive long periods of unfavorable growth conditions, e.g., drought and starvation. When conditions for growth are favorable, spores germinate. Biodeterioration due to fungi has been documented for the following: cellulosic materials (paper, composition board, and wood); communication wire; cable splices; telephone cable; cable sheaths; photographic film; polyvinyl chloride films; sonar diaphragm coatings; map coatings; paints; metals; crude oil; fuel oil; jet fuel; kerosene; greases; waxes; lubricants; adhesives; asphalt; hydraulic fluids; rain repellents; textiles (cotton and wool); vinyl jackets; leather shoes; feathers and down; natural and synthetic rubber; optical instruments; mechanical, electronic, and electric equipment (radar, radio, flight instruments, wire strain gauges, helicopter rotors); hammocks; tape; thermal insulation; brick masonry and concrete; medicines; and museum valuables. In the following sections fungal degradation of polymeric materials and fuels used in aircraft will be reviewed.

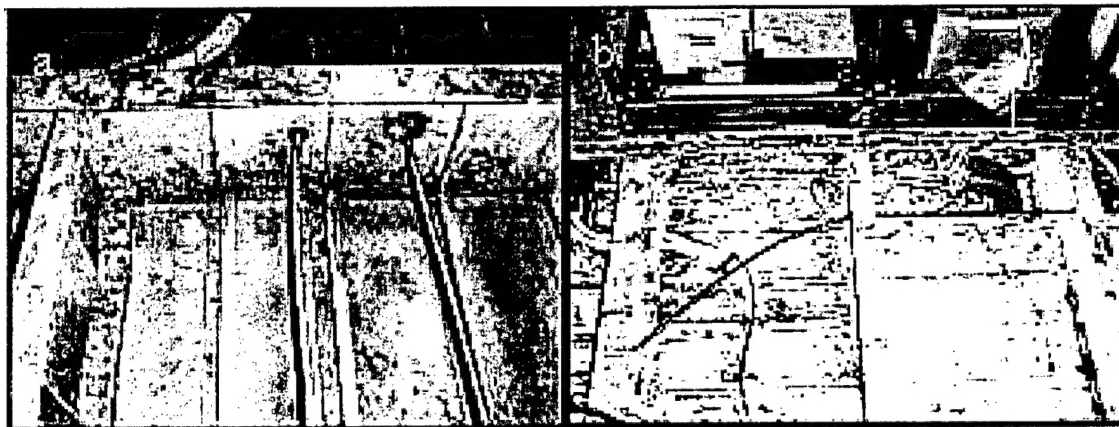
Figure 2. (a-b) areas under floorboards of the MH-53J aircraft containing numerous fungal colonies.

Fungi could be cultured from all surfaces of all platforms. Contamination was typically visible as brown and black patches of fungal hyphae and spores (Figure 2). Little species diversity was observed among the platforms despite their operation in different locations and their repair and overhaul maintenance at the depot. The following isolates were identified: *Aureobasidium*, *Alternaria*, *Penicillium*, *Fusarium*, *Epicoccum*, *Trichoderma*, *Aspergillus*, *Bispora*, *Hormoconis*, *Mucor*, *Phoma*, *Pestalotia*, *Phialomyces*, *Stemphylium* and *Nigrospora*. In all cases *Aspergillus* and *Hormoconis* were present. *Mucor* and *Phoma* were isolated from one platform and *Phialomyces* from two locations on a single platform. Superficial black discolorations were usually due to the presence of *Aureobasidium*, *Alternaria* and/or *Penicillium*. Pink deposits were due to *Epicoccum* or *Aspergillus*. Distribution of organisms was not limited to standing water/fluids, but could be cultured from virtually all interior helicopter surfaces, including primer-coated and polyurethane coated aluminum, fiberglass structural members, caulking, synthetic fabrics, wiring, air-conditioning ducts, cockpits and bay areas. Concentration of organisms did depend on the availability of nutrients and water. Fungi were more numerous in low areas and occluded spaces holding water or hydraulic fluid. A piece of peeling paint removed from an overhead area was uniformly colonized by fungi (Figure 3a). Environmental scanning electron microscopy (ESEM), was used to document fungal contamination on surfaces. Patches of fungi were also located on the primer side (Figure 3b). Fungi penetrated the coating combination, but not the chromate primer. Laboratory analysis of freshly collected MIL-H-83282 hydraulic fluid from a reservoir indicated no fungal contamination.

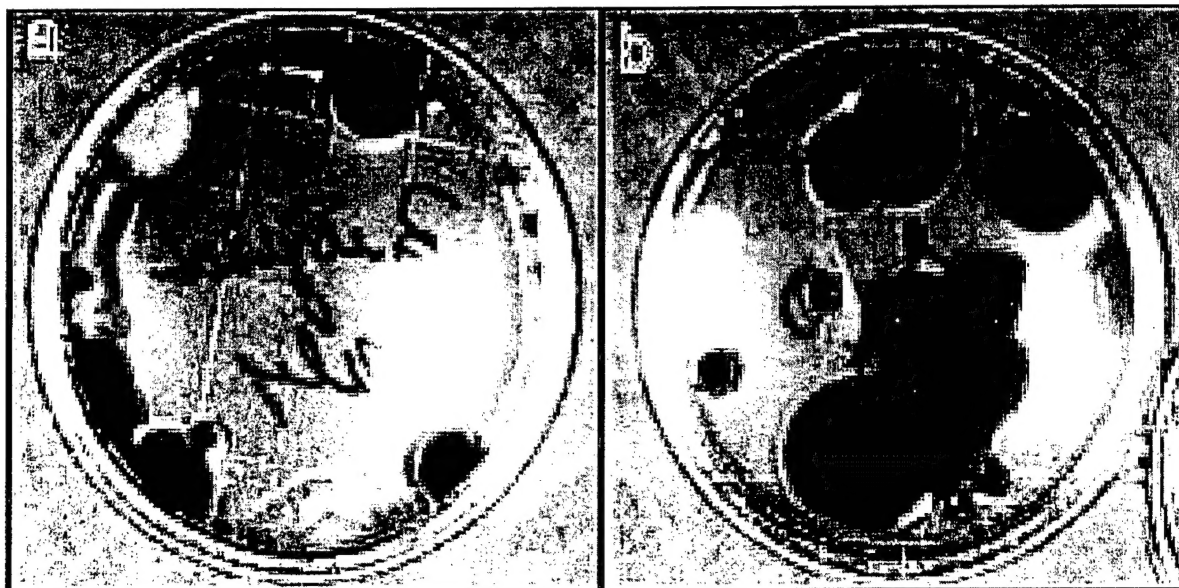
**Figure 5.** Contact plates made from surfaces of a freshly cleaned MH-53J aircraft in the field. (a) contact plate from Figure 4, b3. (b) contact plate from Figure 4, b2. Plates show growth from spores or hyphae left on the surfaces after cleaning.

In situ cleaning of a contaminated bulkhead (Figure 4) was ineffective, as demonstrated by contact PDA plates made after cleaning (Figure 5). The numbers and types of fungi cultured from the surfaces were altered by the cleaning techniques.

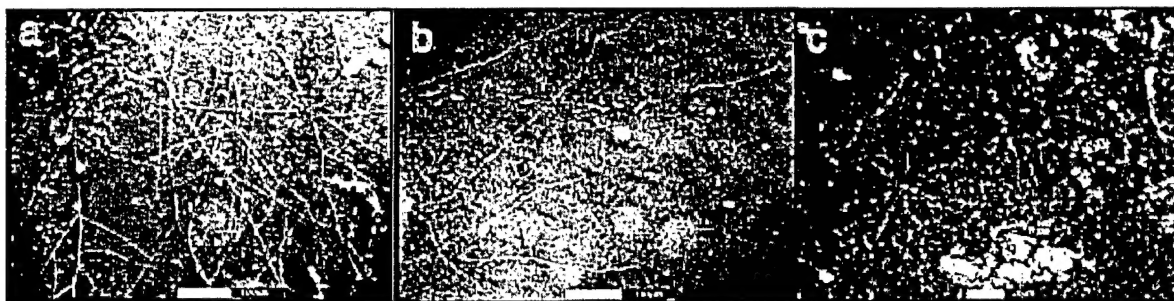
**Figure 6.** Cleaning experiment with the Deft X containing panel from figure 10. (a) ESEM micrograph of the upper portion of the panel prior to cleaning. (b) same section after cleaning with detergent and water followed by 100% isopropanol. (c) same section after 45 days showing fungal hyphae and spores.

In the laboratory a heavily fouled coupon coated with gloss gray (color 16251) polyurethane containing Deft additive (Figure 6a) was used for a cleaning experiment. The coupon was washed with warm water and (MIL-C-85570) detergent followed by a rinse with 100% isopropanol. ESEM micrographs demonstrate that the washes removed most of the fungal spores, but many of the hyphae remained (Figure 6b). After 45 days, regrowth of hyphae left on the surface and the presence of spores could be demonstrated (Figure 6c). Regrowth was found in the immediate area of cleaning and from contaminated adjacent areas that had not been cleaned. In laboratory tests using the ESEM to obtain images before and after cleaning it was possible to demonstrate that only spores were removed or in some cases relocated by the cleaning procedures so that immediately after cleaning the hyphae would continue to grow in the presence of water and nutrients.

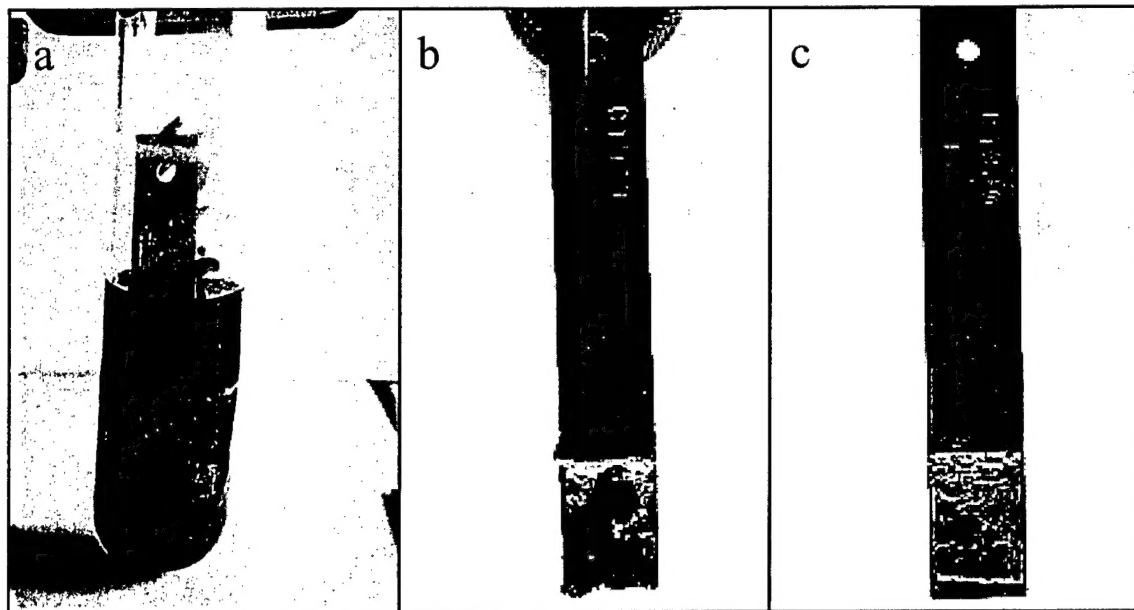
**Figure 7.** a. Carbon steel coupon in jet fuel 5/water combination. Microorganisms growing at fuel/water interface. b. Coupon after removal for fuel/water combination. Microorganisms accumulated on the surface of the coupon at the fuel/water interface. c. Coupon after removal of the biofilm. Corrosion localized at the fuel/water interface and at the bottom of the coupon.

*Aspergillus*, *Penicillium* and *Fusarium* were identified in the fuel/water mixtures. Corrosion attack was located near the tank bottom at the fuel/water interface where an active microbiological population was associated with free water (Fig. 7 a, b, c). Fungi were observed growing over the entire surface of oil droplets and within suspended water droplets (Fig. 8 a, b). In the absence of water, no fungi were detected. Water-soluble biocides are routinely added to fuel to prevent microbial growth. Problems occur when the biocides are exhausted or the amount of water has been underestimated. Attempts to form emulsions of fuel/water combinations accelerate fungal growth by increasing the surface fuel/water interfacial area and, therefore, the availability of oil, oxygen, and nutrients.

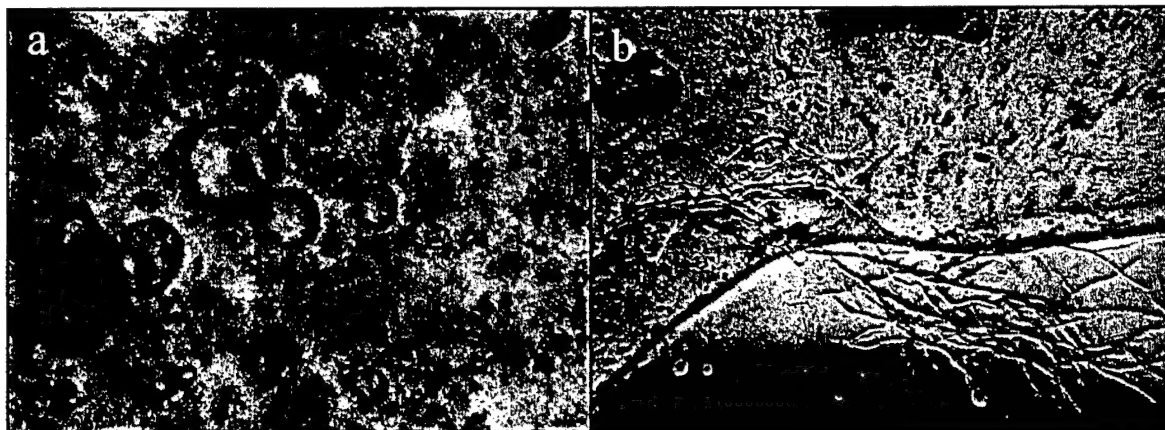
**Figure 8.** a. Water droplets distributed throughout jet fuel 5. b. Fungi growing within a water droplet through the fuel/water interface into the fuel.
